**LIQUEFACTION EFFECTS AND ASSOCIATED DAMAGE
AT THE PORT OF WELLINGTON**

Version 1.0: 22 JUNE 2017

This is QuakeCoRE publication number 0198 and UC Research Report 2017-8. The content is identical with Chapter 5 of GEER Report Number: GEER-053 and UC Research Report 2017-7.

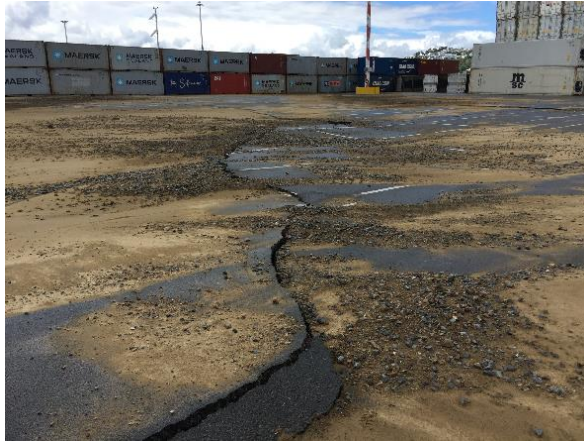
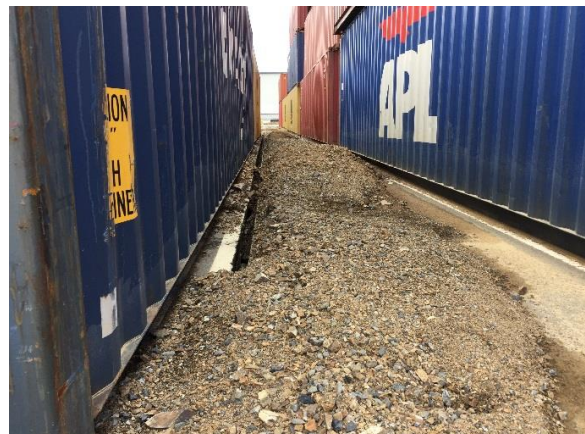
Figure 4.1: Gravelly ejecta at the Thorndon Container Terminal: (a) pavement cracking and ejected gravelly material (S41.280175°, E174.787308°); (b) characteristic gravel-size fractions of the ejecta with some cobbles observed in this area (S41.280206°, E174.787431°); (c) larger amount of gravelly ejecta around a cavity and collapsed pavement surface (S41.280361°, E174.789336°); (d) large volumes of ejecta observed along drainage lines (S41.278347°, E174.788069°, taken on 17NOV16).

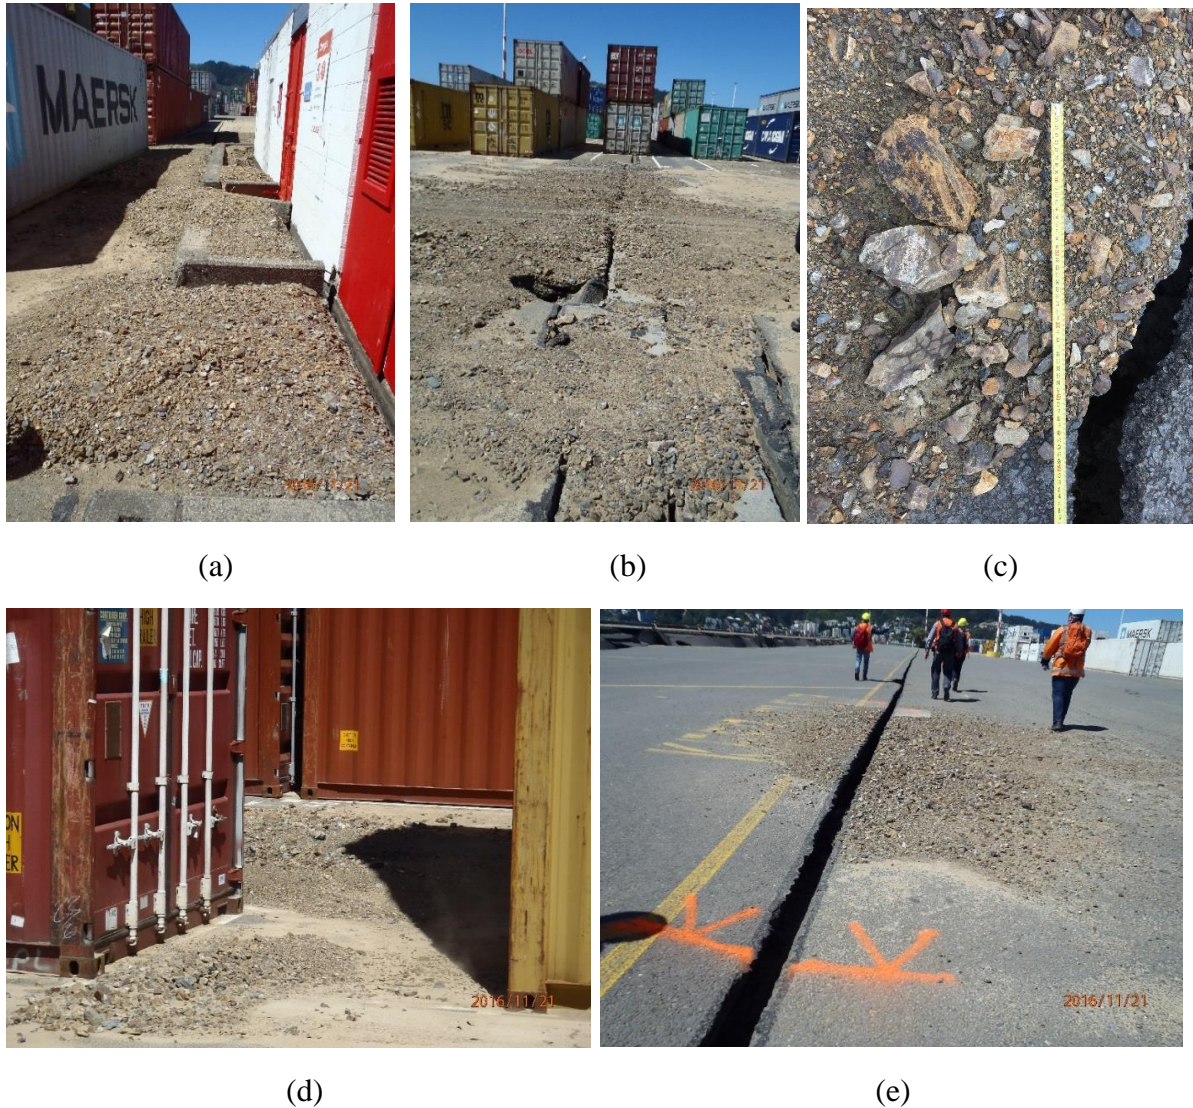
Figure 4.2: High gravel content quarry rock ejecta in the container storage area upland of Thorndon Container Wharf. (a) Looking south along eastern wall of Substation B ($S41.277699^\circ$, $E174.788277^\circ$), (b) looking south along lateral spread crack and ejecta 45 m upland of bulkhead at approximately STA 230 ($S41.278286^\circ$, $E174.788830^\circ$), (c) coarse gravel and cobble ejecta ($S41.280225^\circ$ $E174.787828^\circ$), (d) containers 20 m south of Substation B ($S41.278020^\circ$, $E174.788213^\circ$), and (e) looking south along lateral spread crack and ejecta 12.5 m upland of bulkhead at approximately STA 150 ($S41.278887^\circ$, $E174.789413^\circ$, taken on 21NOV16).

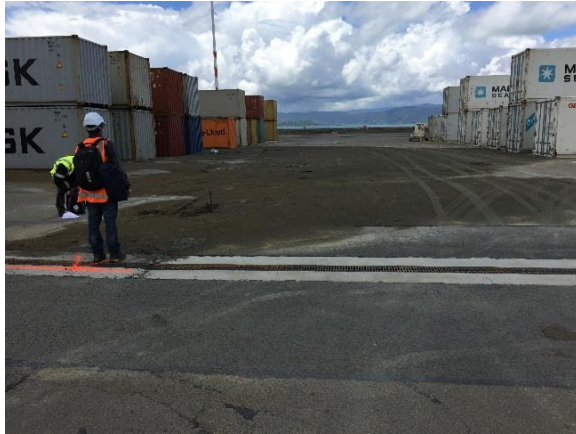
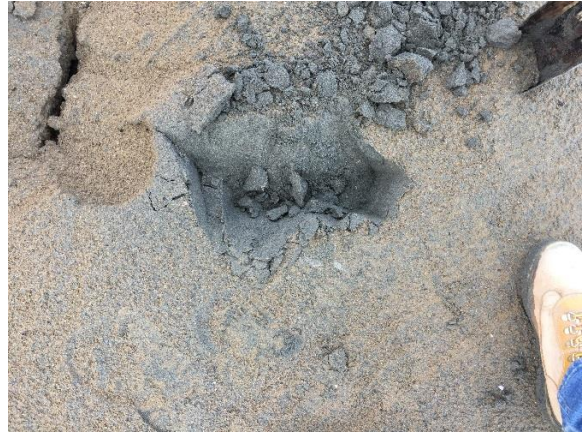
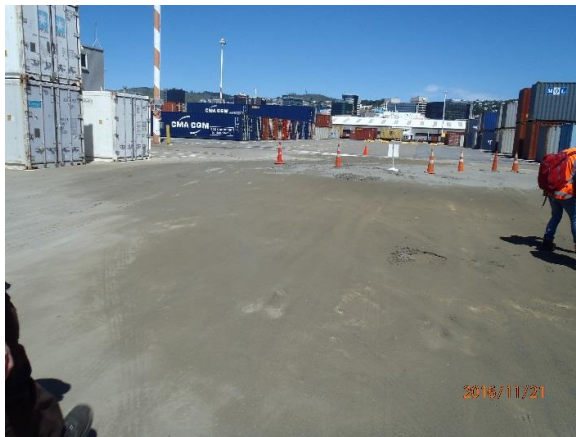
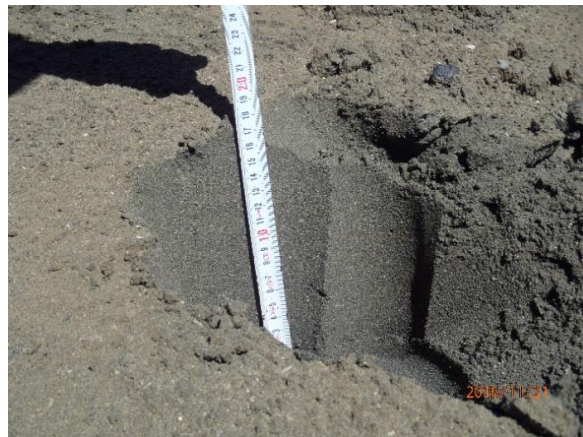
Figure 4.3: Sandy liquefaction ejecta with trace gravel among area of 1970's end-dumped quarry rock reclamation (i.e., Thorndon Reclamation) at STA 145 and approximately 60 m upland of the bulkhead. The ejecta deposit was approximately 170 mm thick at this location. Samples S11 and S12 were collected here (S41.279067°, E174.788792°, taken on 17NOV2016 and 21NOV16).

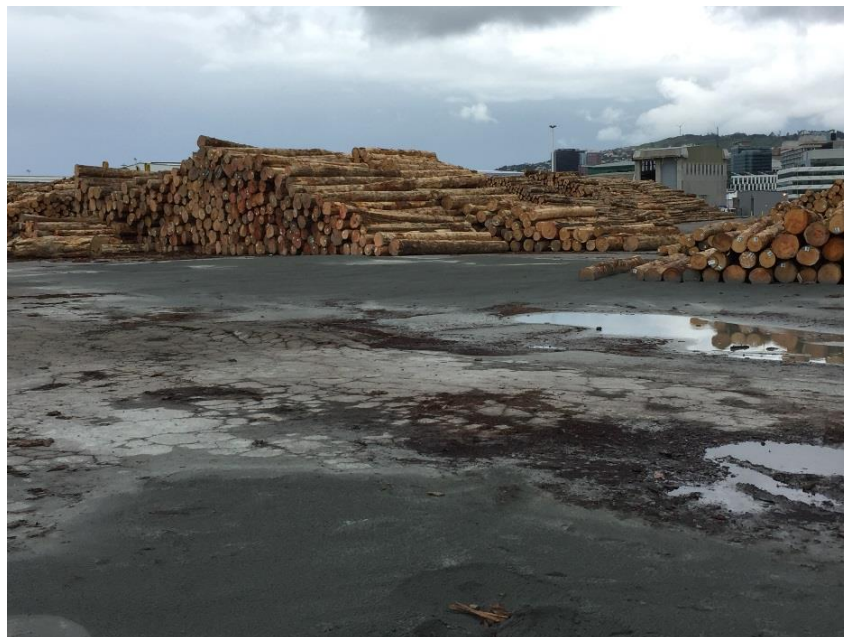
Figure 4.5: Sandy liquefaction ejecta in the log stacking area in the northeast corner of CentrePort (Sample S13). Area of hydraulic fill reclamation. (S41.274972°, E174.788347°, taken on 17 NOV16)

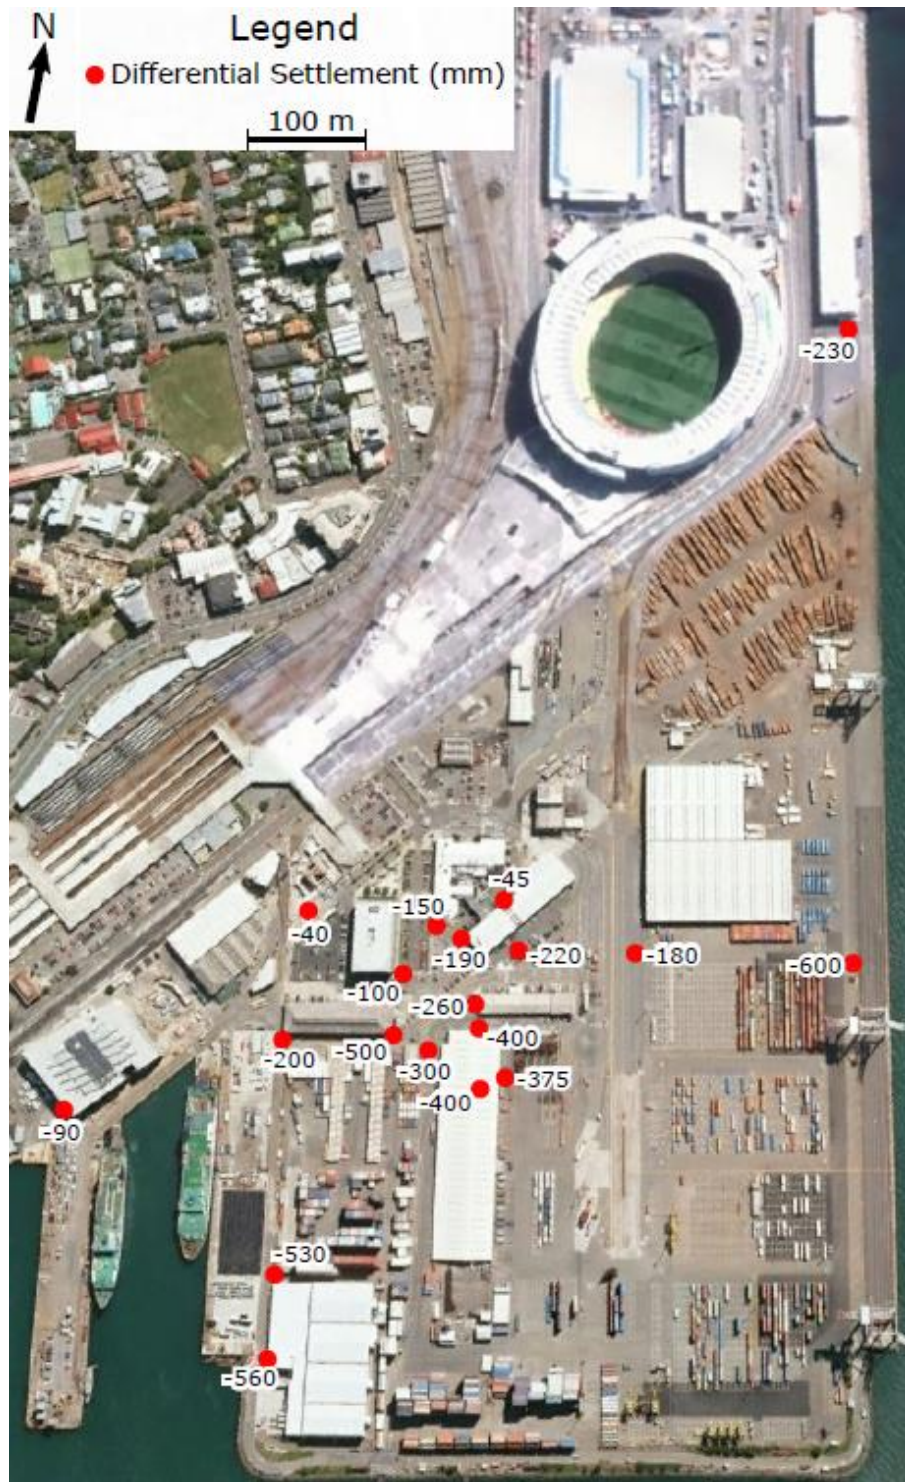
Differential hand-measured vertical settlement measurements are summarized in Figure 4.8. These measurements are of ground settlement relative to pile supported structures. Settlement of fill relative to buildings supported on a shallow foundation are excluded from this figure. The settlement of the fill south of the Old Seawall is generally in the range from 300 mm to 500 mm, whereas settlement of the order of 100 mm to 200 mm was observed in the hydraulic fill north of the seawall. The largest settlement was observed at the Thorndon Container Terminal just behind the wharf where a vertical offset of about 600 mm was observed. Approximately 180 meters inland of the Thorndon Wharf bulkhead, 180 mm of settlement were measured relative to what appeared to be the piles of the historic gantry crane at North Rail (see Figure 2.2).

Figure 4.8: Location and magnitude of differential settlement measurements obtained during inspections. All values are in mm, and represent settlement of the ground surface relative to a pile supported structure. (Base image from Google Earth™)

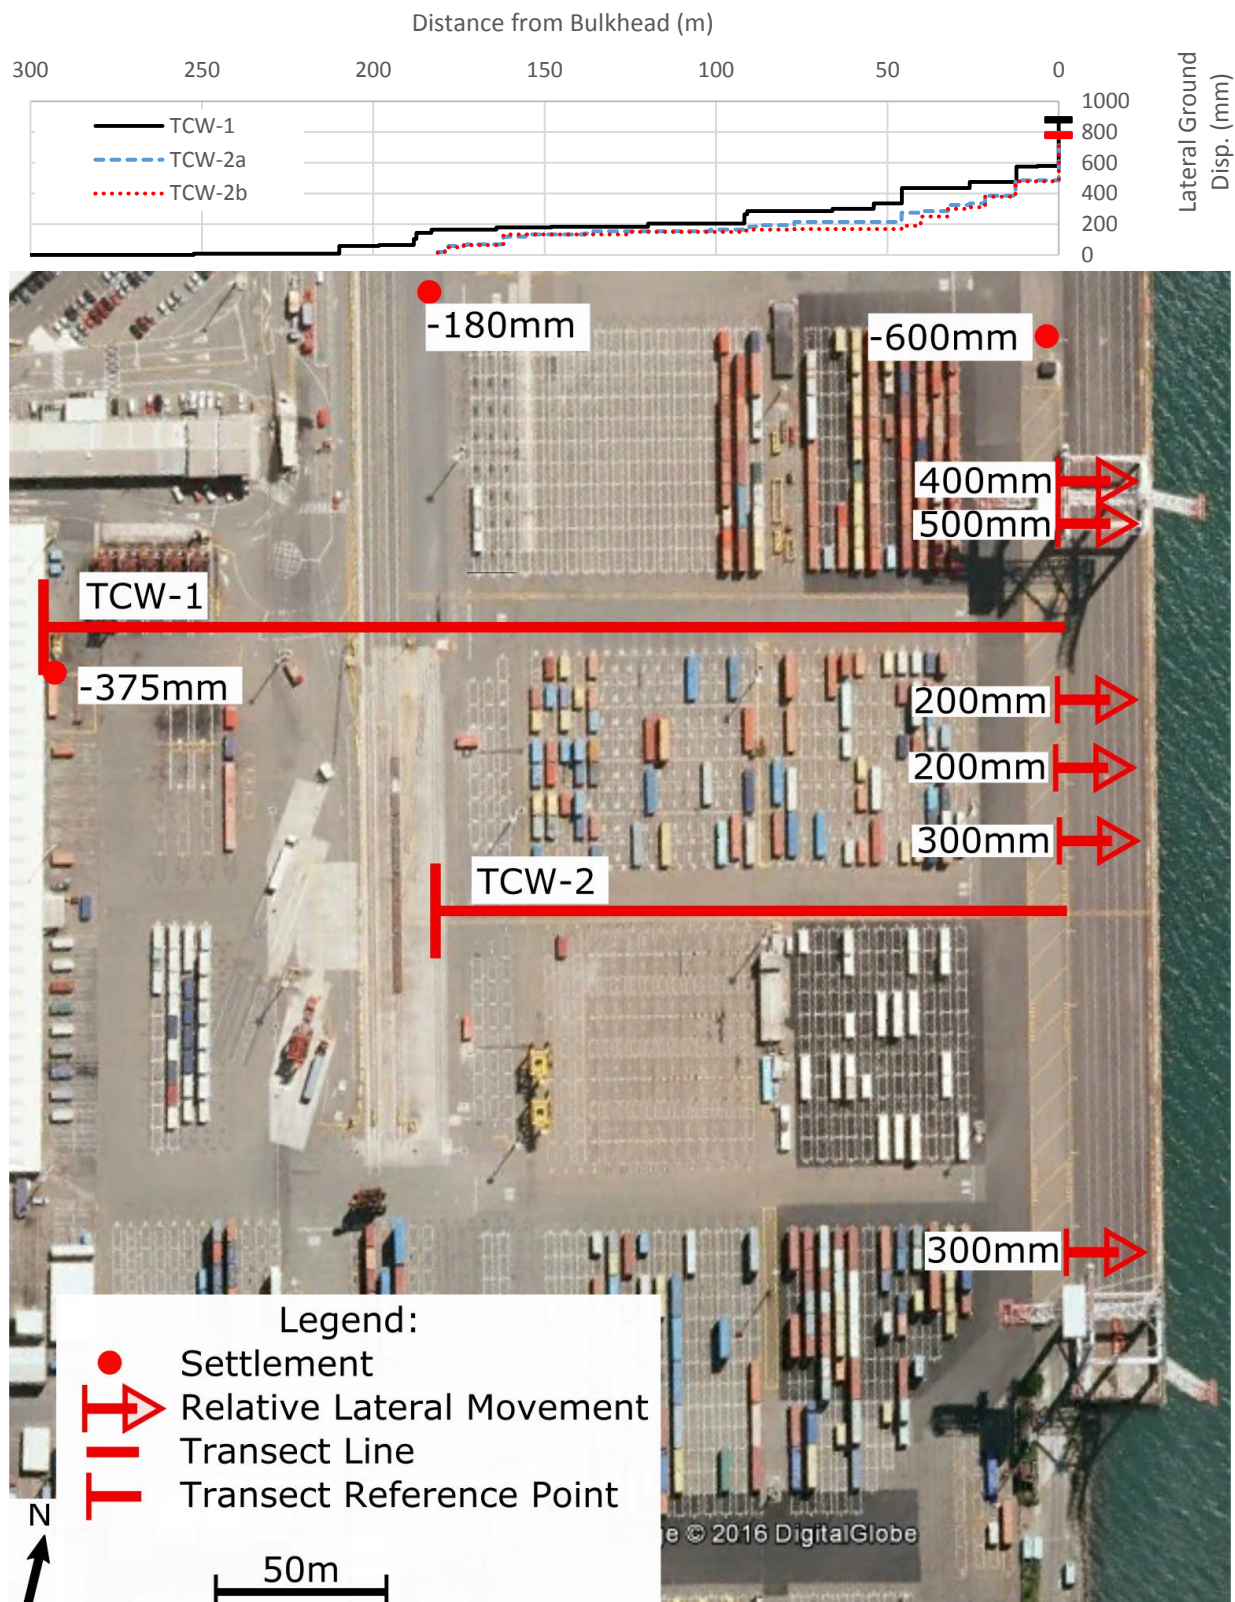
To quantify the magnitude and spatial distribution of lateral spreading at TCT, lateral spreading measurements were performed by ground surveying along two transects in the east-west direction, denoted as TCW-1 and TCW-2 in Figure 4.9. Along each transect, ground cracks were identified and their location (horizontal distance from a reference point) and width were recorded. By summing up the crack widths one can estimate the size of lateral ground displacements as a function of the distance inland from the wharf, as illustrated in the plot shown at the top of Figure 4.9. Note that along TCW-2 two independent transects were performed approximately 10 m apart (in the N-S direction) to check the accuracy in the estimates of ground displacements. Table 4.2 lists the width and horizontal distance to each crack from the reference point of each transect. The cumulative opening of the cracks measured across TCW-1 and TCW-2 are 960 and 785 mm, respectively, implying that the edge of the fill moved laterally towards the sea (Thorndon Wharf) about 0.8 m to 1.0 m.

Figure 4.9: Location of west-to-east transects for lateral spreading measurements towards Thorndon Wharf during inspections. Plots at the top show cumulative lateral ground displacement versus horizontal distance from the bulkhead. Transect measurements are in Table 4.2. (Base image from Google Earth™)

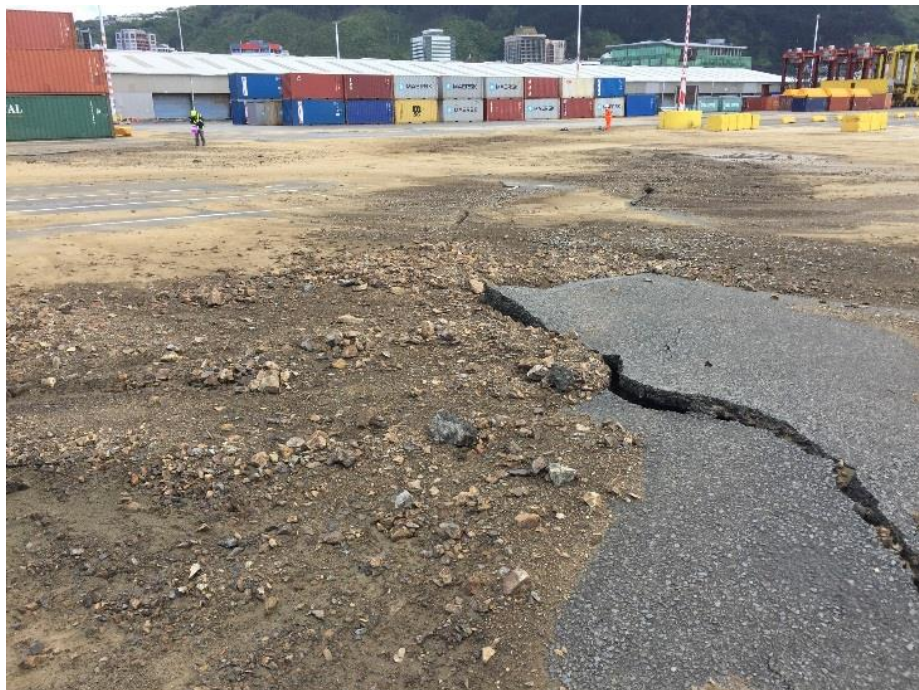
Figure 6.2: Widespread liquefaction of gravelly end-dumped quarry rock reclamation in container stacking area inland of Thorndon Wharf (S41.276608° E174.786309°, taken on 21NOV16)

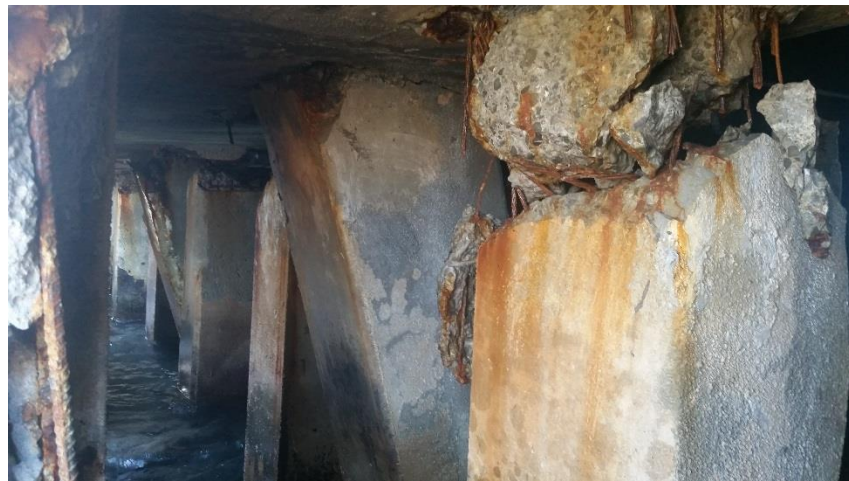
The QuakeCoRE-GEER team was informed that concrete piles had been sheared near the pile cap (from a boat survey by others; T+T (2016) private communication). From the south side of the port, the QuakeCoRE-GEER team did observe a vertical bulkhead pile sheared just below the pile cap (Figure 6.5a). During a site visit in May 2017, the team observed that the bulkhead piles (both plumb and battered) near the north end of the Thorndon Reclamation were damaged immediately below the deck (Figure 6.5b). Cardno performed an aerial survey of the port that captured vertical settlement and lateral movement, which is shown in Figure 6.6. The magnitude of lateral spreading displacement and settlement measured by Cardno are generally consistent with those measured by the QuakeCoRE-GEER team, which are provided in this report.

Figure 6.5: (a) Looking north towards the southern end of Thorndon Wharf. The vertical bulkhead pile is sheared just below the pile cap. QuakeCoRE-GEER team was informed that many piles in this area were sheared near the pile cap (from a boat survey by others; T+T (2016) private communication) (S41.280219° E174.789974°, taken at 1152 hrs on 22NOV16) (b) Looking north under the Thorndon Wharf bulkhead toward damaged plumb and battered bulkhead piles. (S41.277312° E174.789081°, taken at 13:38 hrs on 08MAY17)

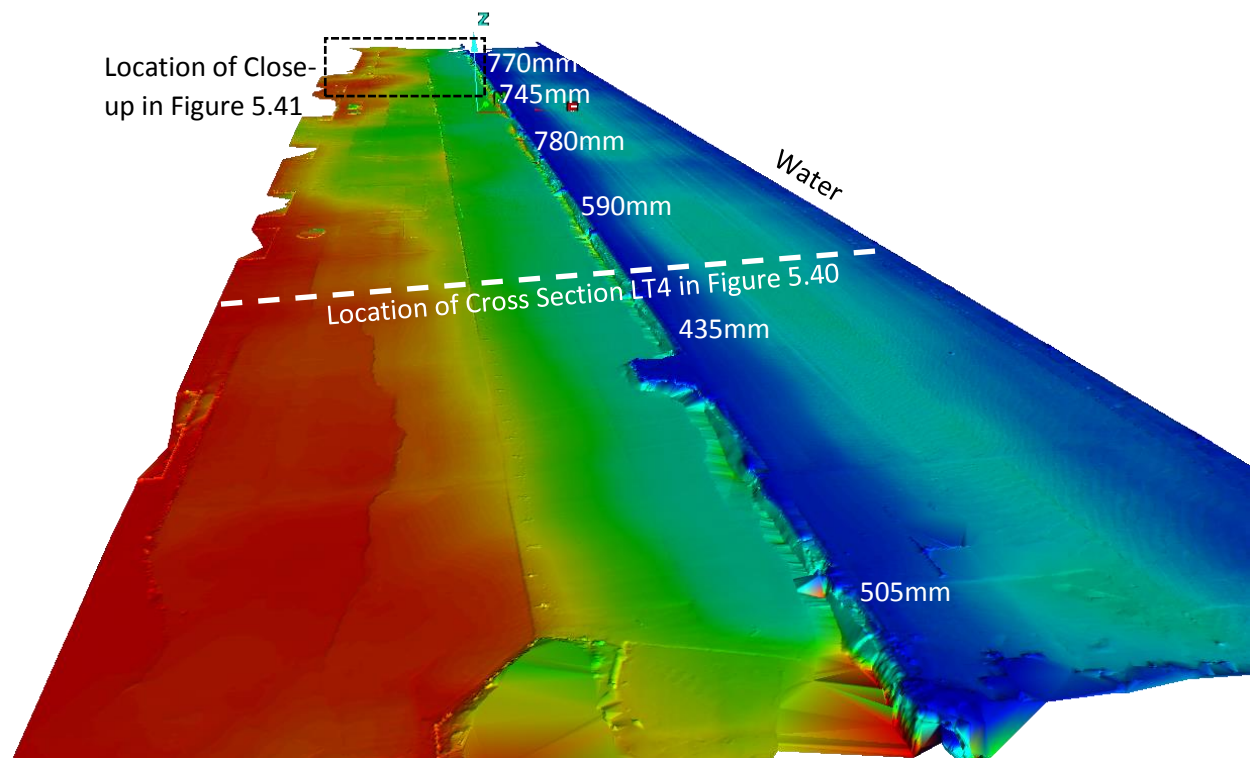
Figure 6.7 shows the LiDAR-derived DEM for the Thorndon Wharf and surrounding terrain. The wharf deck has substantial concavity as observed in the cross section in Figure 6.8. Differential settlements between the wharf deck and adjacent pavement ranged from 435 mm to 780 mm, generally increasing towards the North. Figure 6.9 provides a close up of ejecta and offsets at the northern end of this portion of the wharf.

Figure 6.7: Perspective view of the LiDAR DEM of the eastern section of the port looking northward including the Thorndon Wharf and surrounding area colored by elevation to highlight discontinuities from cracks. Elevation ranges from approximately 2.60 m (red) to 3.60 m (dark blue). Differential settlements between the Wharf and Port are identified.

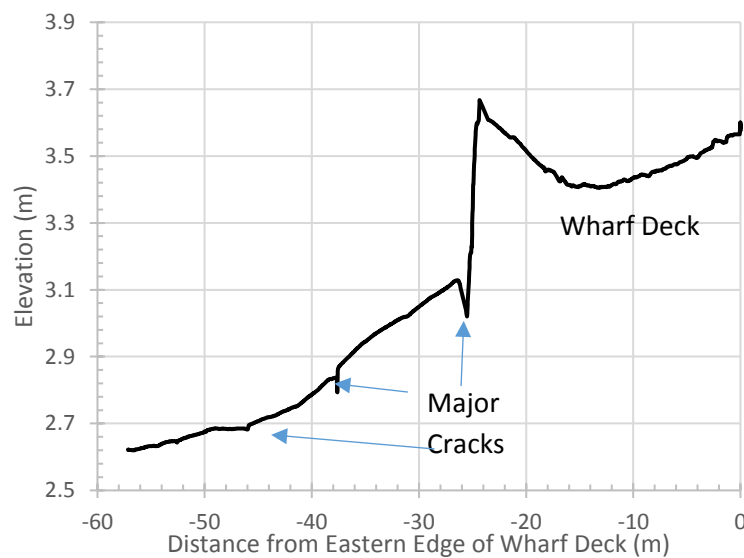
Figure 6.8: Elevation profile for cross section LT4 across Thorndon Wharf and inland fill. The location of the cross section is shown in Figure 6.7.

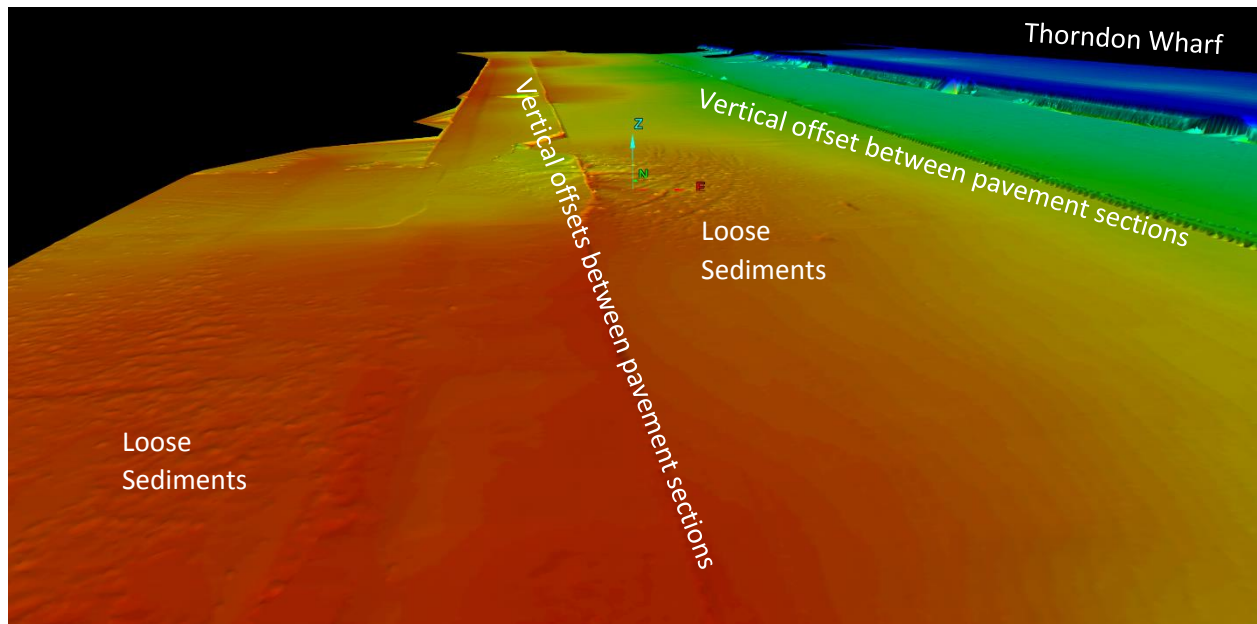
Figure 6.9: Close-up of the port surface highlighting cracking and separation between asphalt sections as well as loose sediments from ejecta (rougher sections of DEM) in the vicinity of Thorndon Wharf (see Figure 6.7).

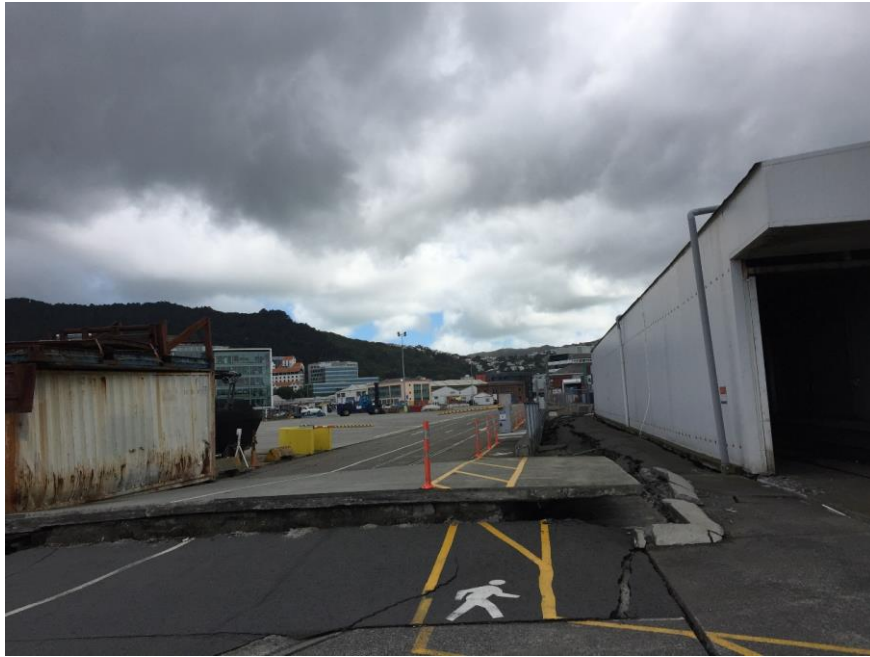
Figure 6.10: Looking North along bulkhead of King's Wharf. Approximately 560 mm of ground settlement relative to deck at southeast corner of King's Wharf. The west wall of the Cold Store shed is visible to the right of the photograph. (S41.281142° W174.784444°, taken at 1416 hrs on 21NOV16)

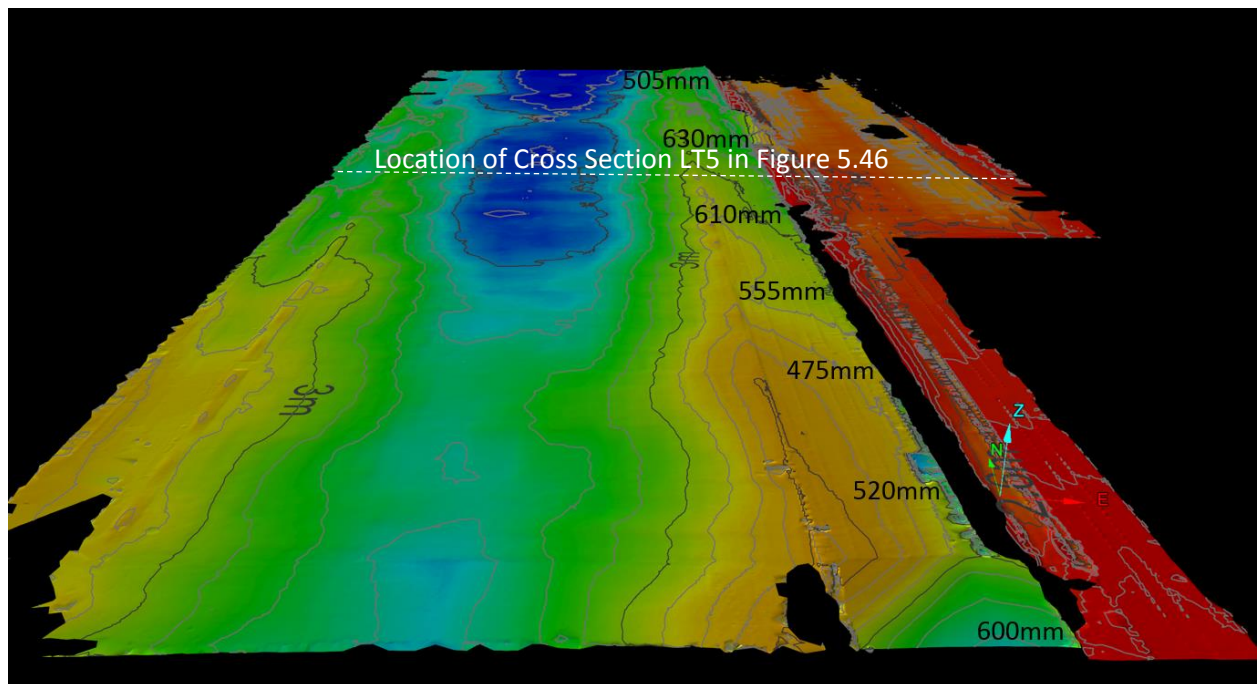
Figure 6.13: Perspective view of the LiDAR derived DEM (looking northward) of the pile supported King's Wharf showing measurements of differential settlement the adjacent ground. Elevation ranges from approximately 2.50 m (red) to 3.30 m (dark blue)

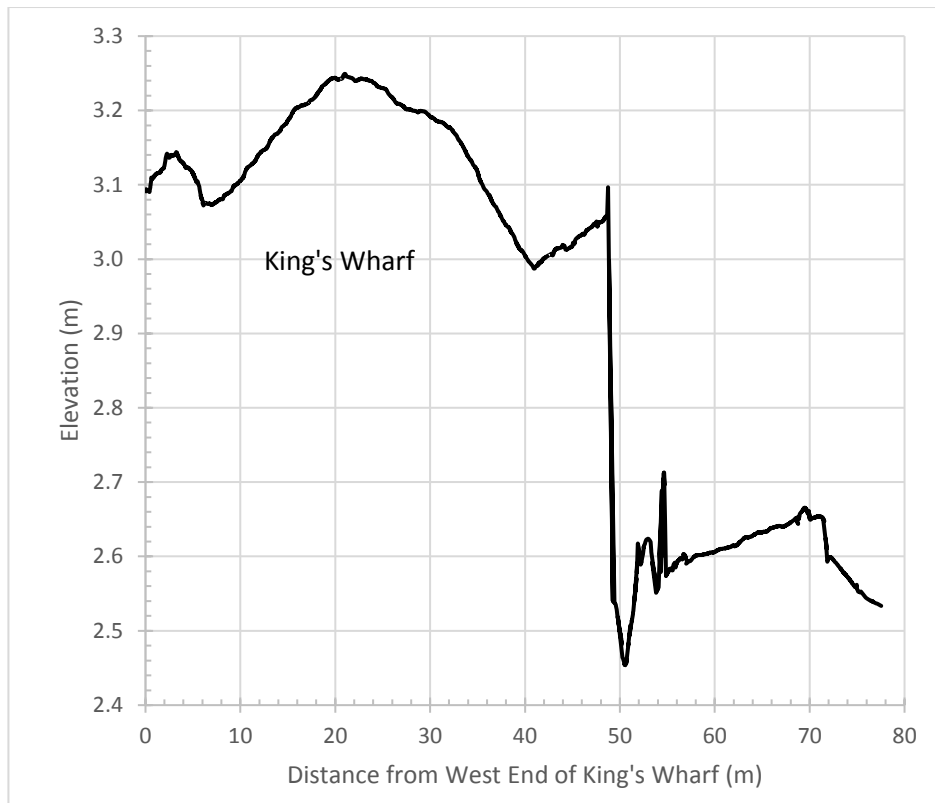
The inland timber piles split due to seaward (westward) lateral movement of the deck relative to the piles (Figure 6.11). Westward movement of the structure is visible in Figure 6.12, in which the southern row of piles is shown leaning to the west. Some vertical curvature of the wharf deck can be observed in the LiDAR DEM (Figure 6.13) and associated cross section in Figure 6.14. Differential settlement between the wharf and adjacent ground range from 475 mm to 630 mm as measured from the LiDAR-derived DEM. The wharf deck exhibits significant concavity (downward) as observed in the cross section plotted on Figure 6.14.

Figure 6.14: Cross section LT5 taken across King's Wharf and the adjacent ground based on LiDAR data shown in Figure 6.13.

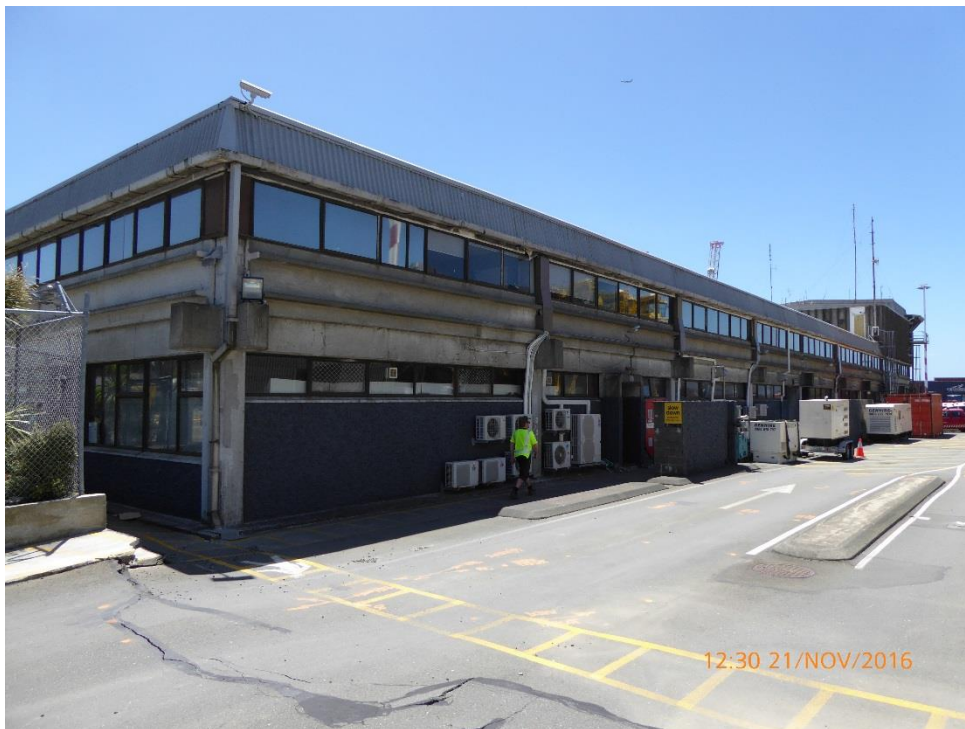
The CPH building (S41.27829° E174.78618°) is founded on reinforced concrete (RC) spread footings connected with RC grade beams (Figure 7.2). There were no apparent signs of structural distress, and the building was operational at the time of the reconnaissance in late November 2016. The building and surrounding fill settled relatively uniformly, however, ground a few meters to the west of the CPH building did not appear to settle significantly as it was elevated relative to the surrounding ground and the floor level of the CPH building. The elevated ground was likely supported by the old bulkhead piles of the demolished Pipitea Wharf (see Figure 2.2), which minimized liquefaction-induced settlement of the ground and pavement above it. The building and fill settled approximately 230 to 260 mm relative to the ground supported on piles, as shown in Figure 7.3. Settlement appeared to be more or less uniform across the building footprint, as there were no apparent signs of relative movement or tilt of the ground floor of the CPH building from the visual investigation. However, a preliminary analysis of the LiDAR scans indicate a slight tilt (i.e., of 0.105 degrees) in the large operations room on the east end of the building.

Figure 7.2: Uniform settlement of CPH building which is founded on shallow foundations that apparently displaced downward the same amount as the surrounding fill. This photo is looking northeast at the southwest corner of the building. (S41.278395° E174.785639°, taken at 1230 hrs on 21NOV16)

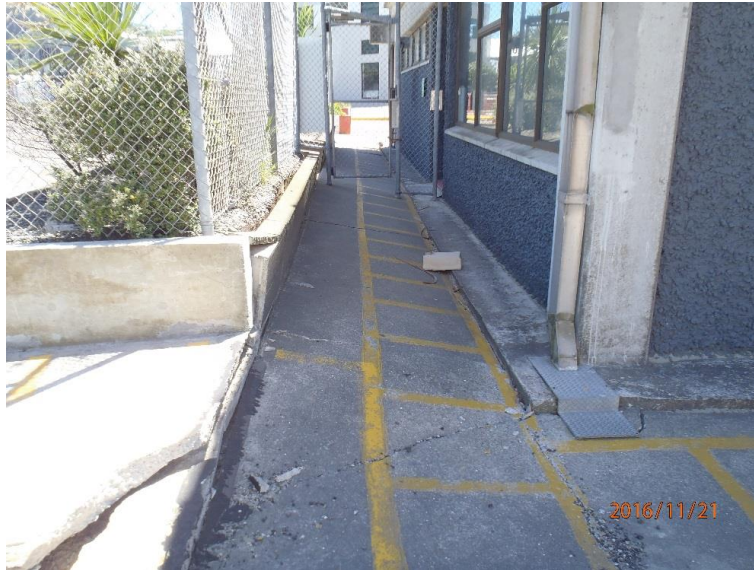
Figure 7.3: Uniform settlement (230-260 mm) of the building relative to ground supported on old bulkhead piles of Pipitea Wharf. Looking north along western wall of CPH building. The perimeter walkway slopes down towards the building at 11 degrees over 1.35 meters. (S41.278395° E174.785639°, taken at 1225 hrs on 22NOV16)

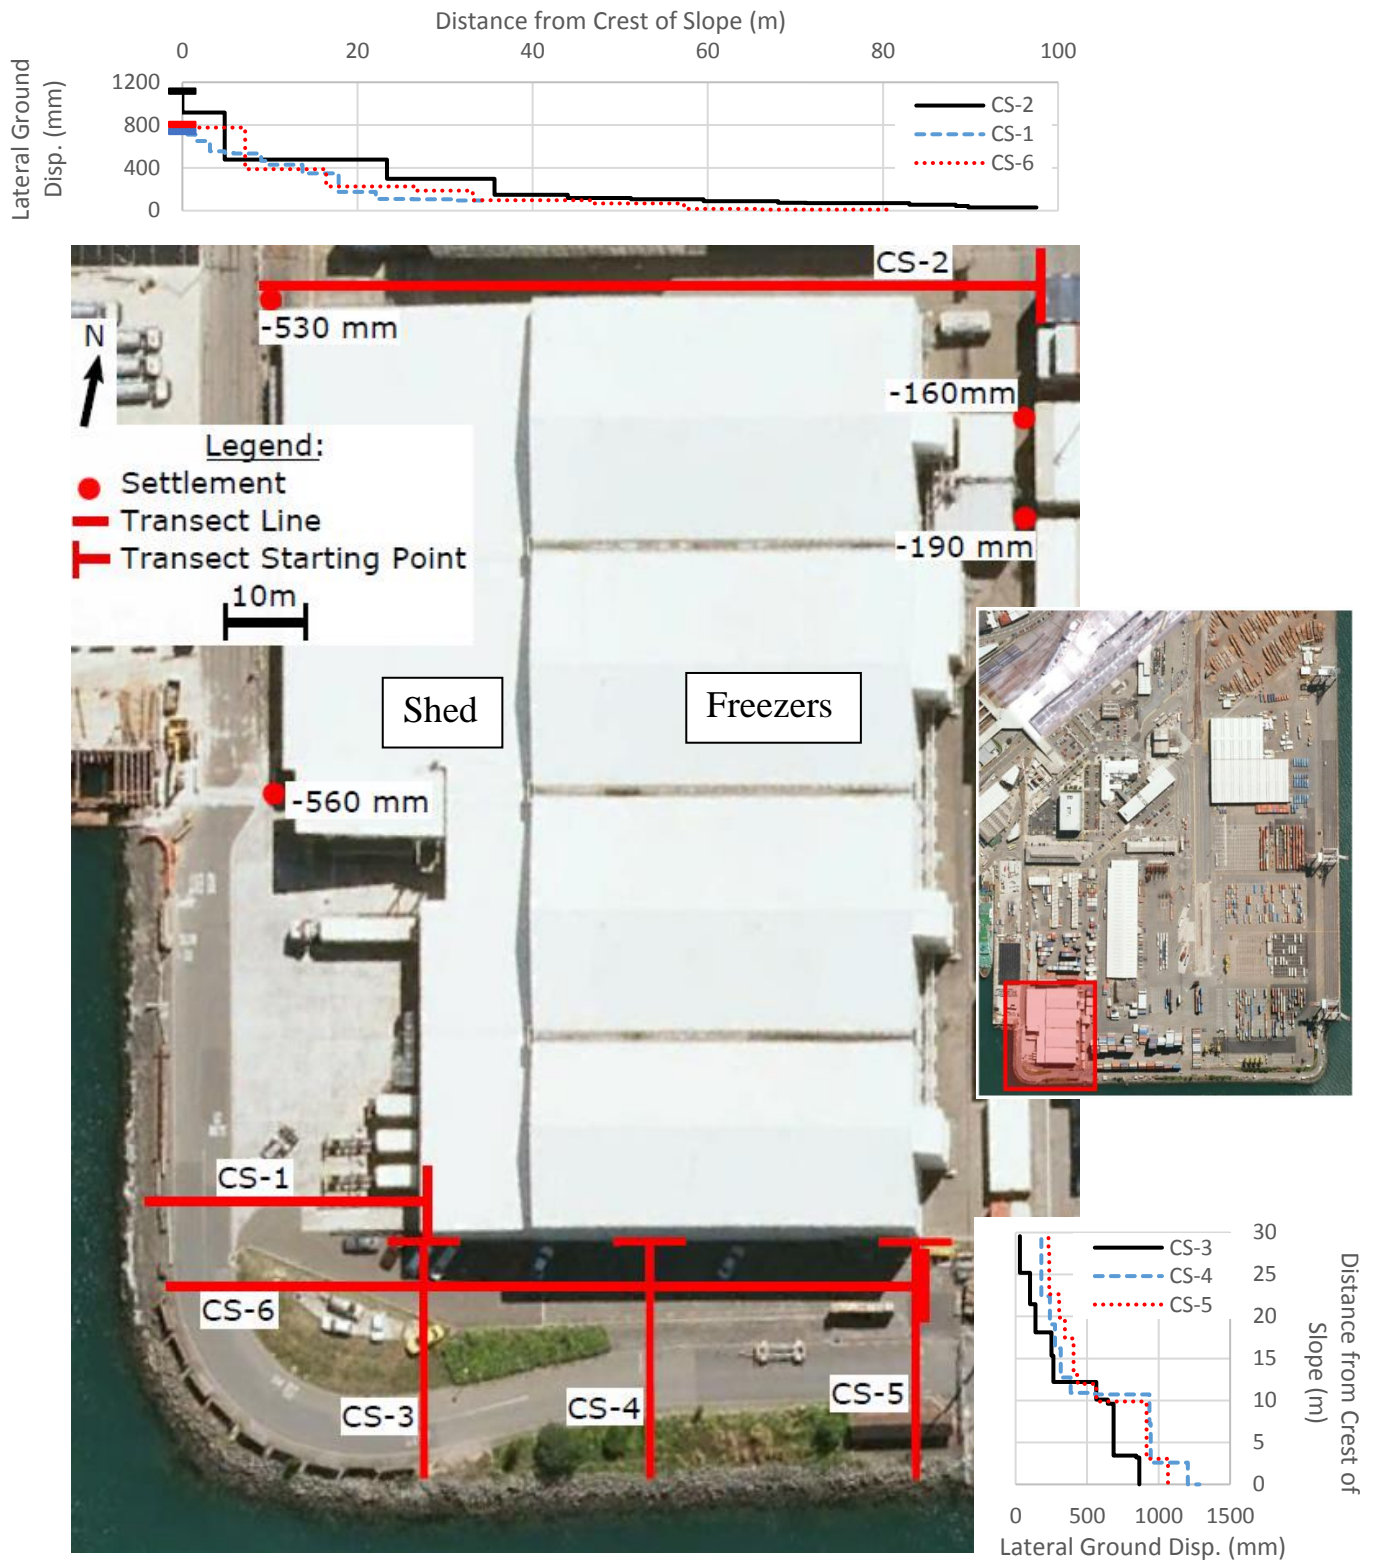
The differential ground movements across the building footprint induced structural deformation in the CS building. Seaward lateral ground movements on the order of 1 m occurred towards the western and southern slopes in the southwest corner the CentrePort reclaimed land. Figure 7.4 shows the location of six transects along which the location and width of lateral ground cracks in the pavement surrounding the CS building were recorded. Superimposed on this figure are plots of cumulative lateral ground displacement as a function of distance from the crest of the waterfront slopes for each transect. They show that, at the south side of the building, the fill moved towards the sea (southward) approximately 0.8 to 1.3 m. Similarly, the fill moved 0.8 to 1.1 m to the west direction. The top plot in Figure 7.4 indicates that the foundations of the building were subjected to a lateral stretch of approximately 200 mm. This stretch occurred over a column span of approximately 8.8 m, which corresponds to a lateral strain of about 2.3 percent. Tables 7.1 and 7.2 provide the measured crack widths and distances from the transect reference point for the east-to-west

Figure 7.4: CS building lateral ground movement transects and vertical settlement measurement locations. Cumulative ground displacement versus distance from crest of slope are provided. Note that the crest of slope is further east at CS-2 than at CS-1 and CS-6, therefore, displacement plots do not perfectly align with satellite image for CS-2. Settlement measurements to the northeast are relative to the building which also settled.

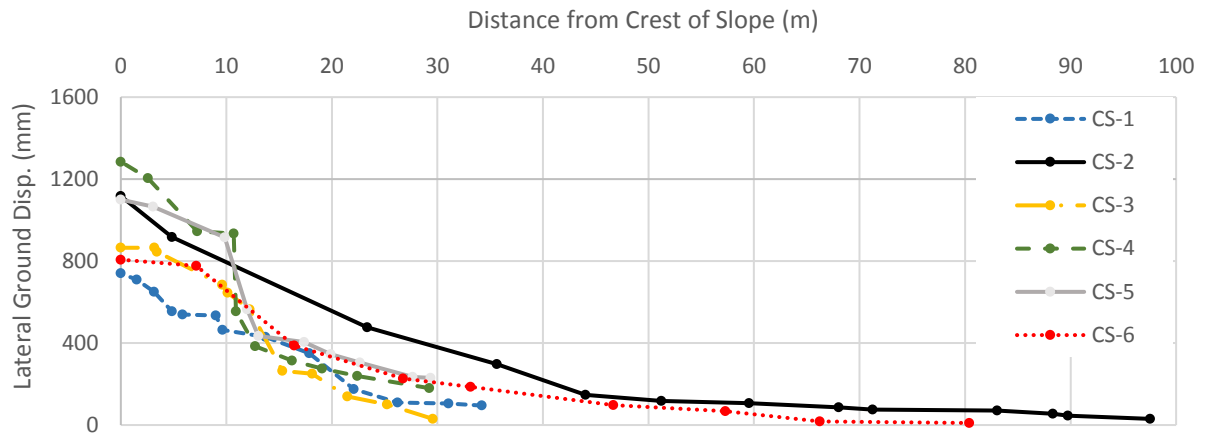
Figure 7.5: Cumulative lateral ground displacement versus distance from the crest of the waterfront slope for Cold Store lateral spread transects.

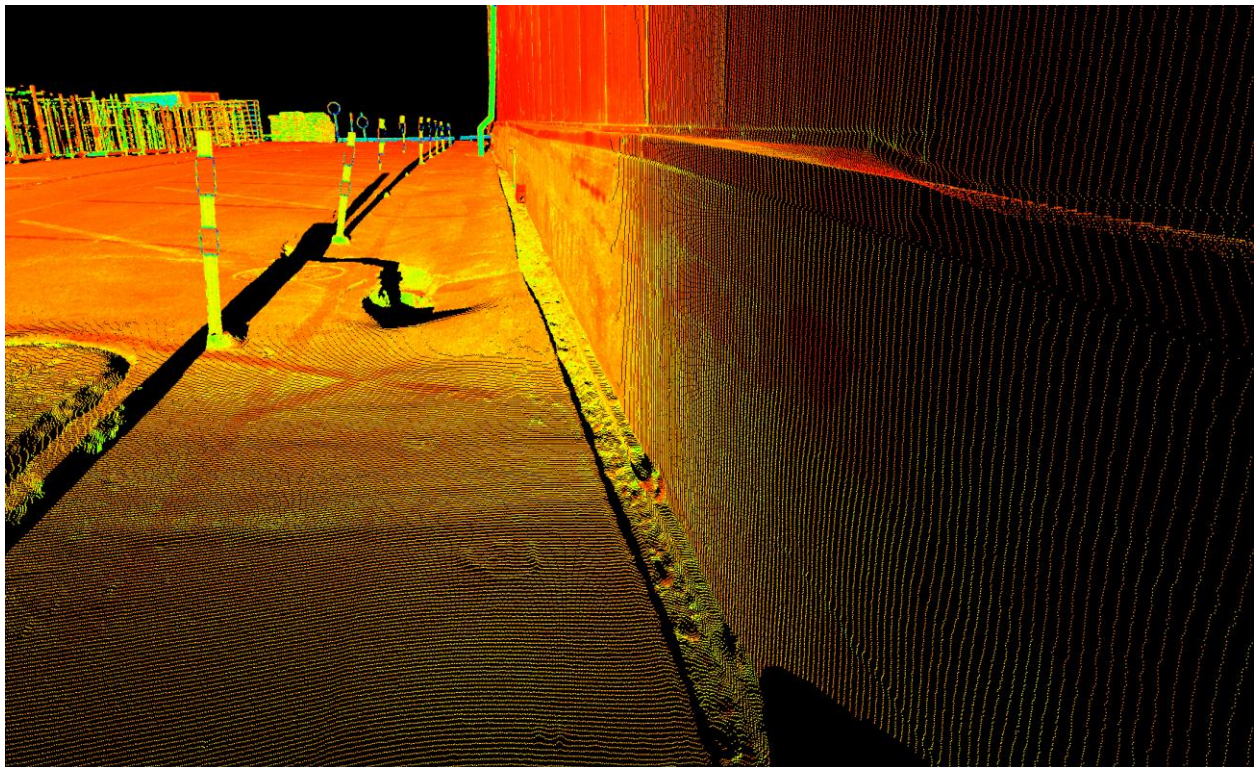
Significant separation between the CS building foundation and pavement slab were observed on the south side of the building (as well as settlement and spreading of the surrounding pavement). Figure 7.6 shows a LiDAR scan documenting this separation, which ranges from 30 mm (west) to 230 mm (east).

Figure 7.6: Perspective view of LiDAR scan looking westward showing the horizontal separation from building foundation and settlement of pavement observed on the south side of the CS building looking west (colored indicates intensity). The separation varies from 0.23 m wide to 0.03 m wide horizontally from the building's eastern side to its western side.

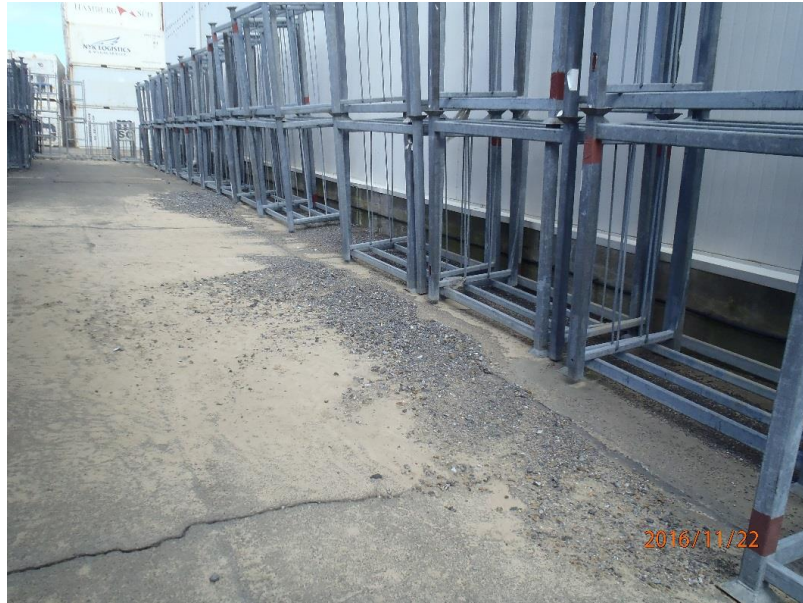
Gravelly liquefaction ejecta was observed around the building (Figure 7.7). Figure 7.8 shows lateral ground movements and partial collapse of the slope at the reclamation edge along the western wall of the Shed of the CS building (which is parallel and adjacent to King's Wharf), where the ground settled approximately 530 mm relative to the King's Wharf. This part of the building is closest to the crest of the slope and it underwent the largest lateral movement. Figure 7.9 shows lateral movements near the crest of the western slope, and Figures 7.10 and Figure 7.11 show lateral spreading towards the southern slope with a vertical offset of approximately 1.1 m. In these large cracks and vertical offsets, shallow soils beneath the pavement were visible and consist of gravelly quarry rock reclamation fill. Crack widths and locations along the bottom of the outside walls of the CS building were also measured. Figure 7.12 shows results of this survey, which are consistent with the previously described lateral spreading measurements and indicate a lateral stretch of the shallow foundation of the Shed of approximately 200 mm in the westward direction.

Figure 7.7: Gravelly liquefaction ejecta looking east along the northern wall of the CS building. (S41.280528° E174.784984°, taken at 1651 hrs on 22NOV16)

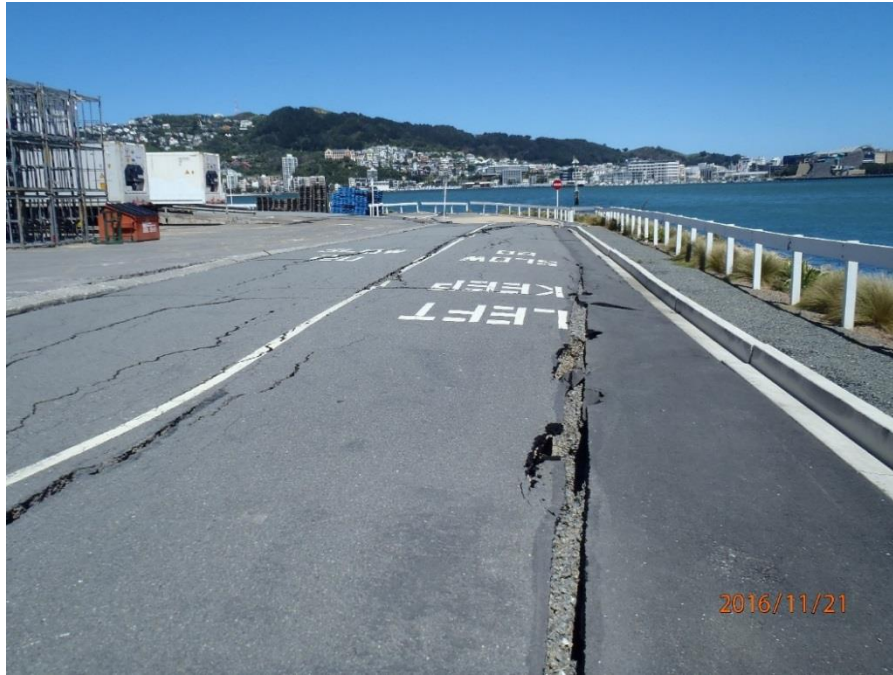
Figure 7.9: Ground cracks in area west of the CS building and along the southwestern slopes of CentrePort (looking south). The CS building can be partially seen on the upper left corner of the photograph. (S41.281478° E174.784430°, taken at 1418 hrs on 21NOV16)

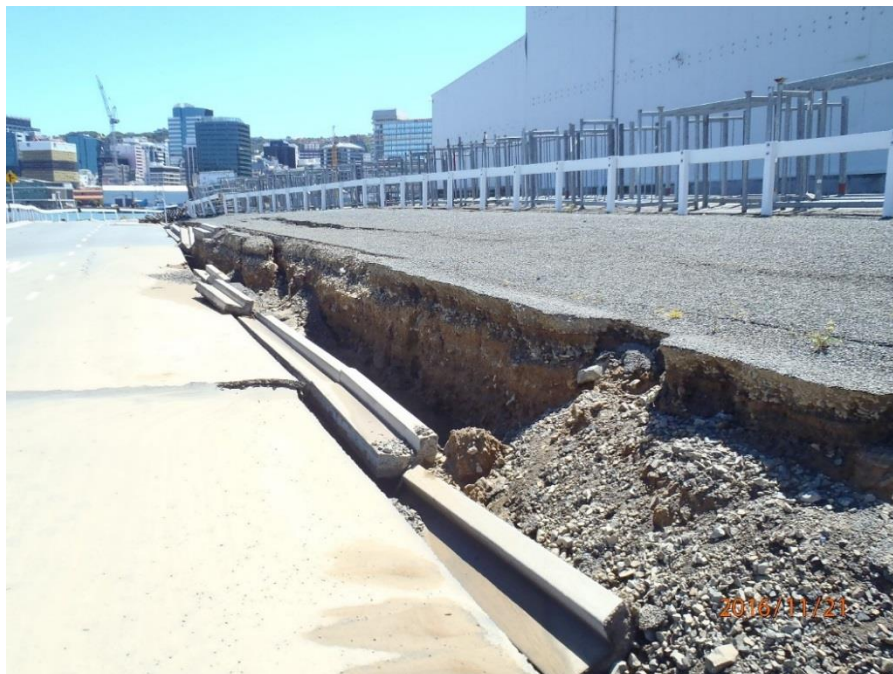
Figure 7.10: Approximately 1.1 m of vertical offset resulting from the southward lateral movement of the southern edge of CentrePort reclaimed land near its western side. Looking west near the southern wall of the CS building. (S41.281701° E174.785268°, taken at 1427 hrs on 21NOV16)
